# New York State Department of Transportation

## Yellow Flag NB2222W004

**BIN: 1065318**  
**Feature Carried:** 278I278IX2M23027  
**Feature Crossed:** 6TH AVENUE  
**Orientation:** 8 - NORTHWEST  
**Region:** 11 - NEW YORK CITY  
**County:** KINGS  
**Political Unit:** City of NEW YORK  
**Approximate Year Built:** 1962  
**Posted Load Matches Inventory :** Yes  
**Bridge Load Posting (Tons) :** Not Posted for Load  
**Primary Owner:** New York State Department of Transportation  
**Primary Maintenance Responsibility:** 12 - State - Subcontracted to another Party  
**Typical or Main Span Type:** 3 - Steel, 02 - Stringer/Multi-Beam or Girder  
This Bridge is not a Ramp  
**Number of Spans:** 322

Location: Span 247, Girder G19 at Pier 247

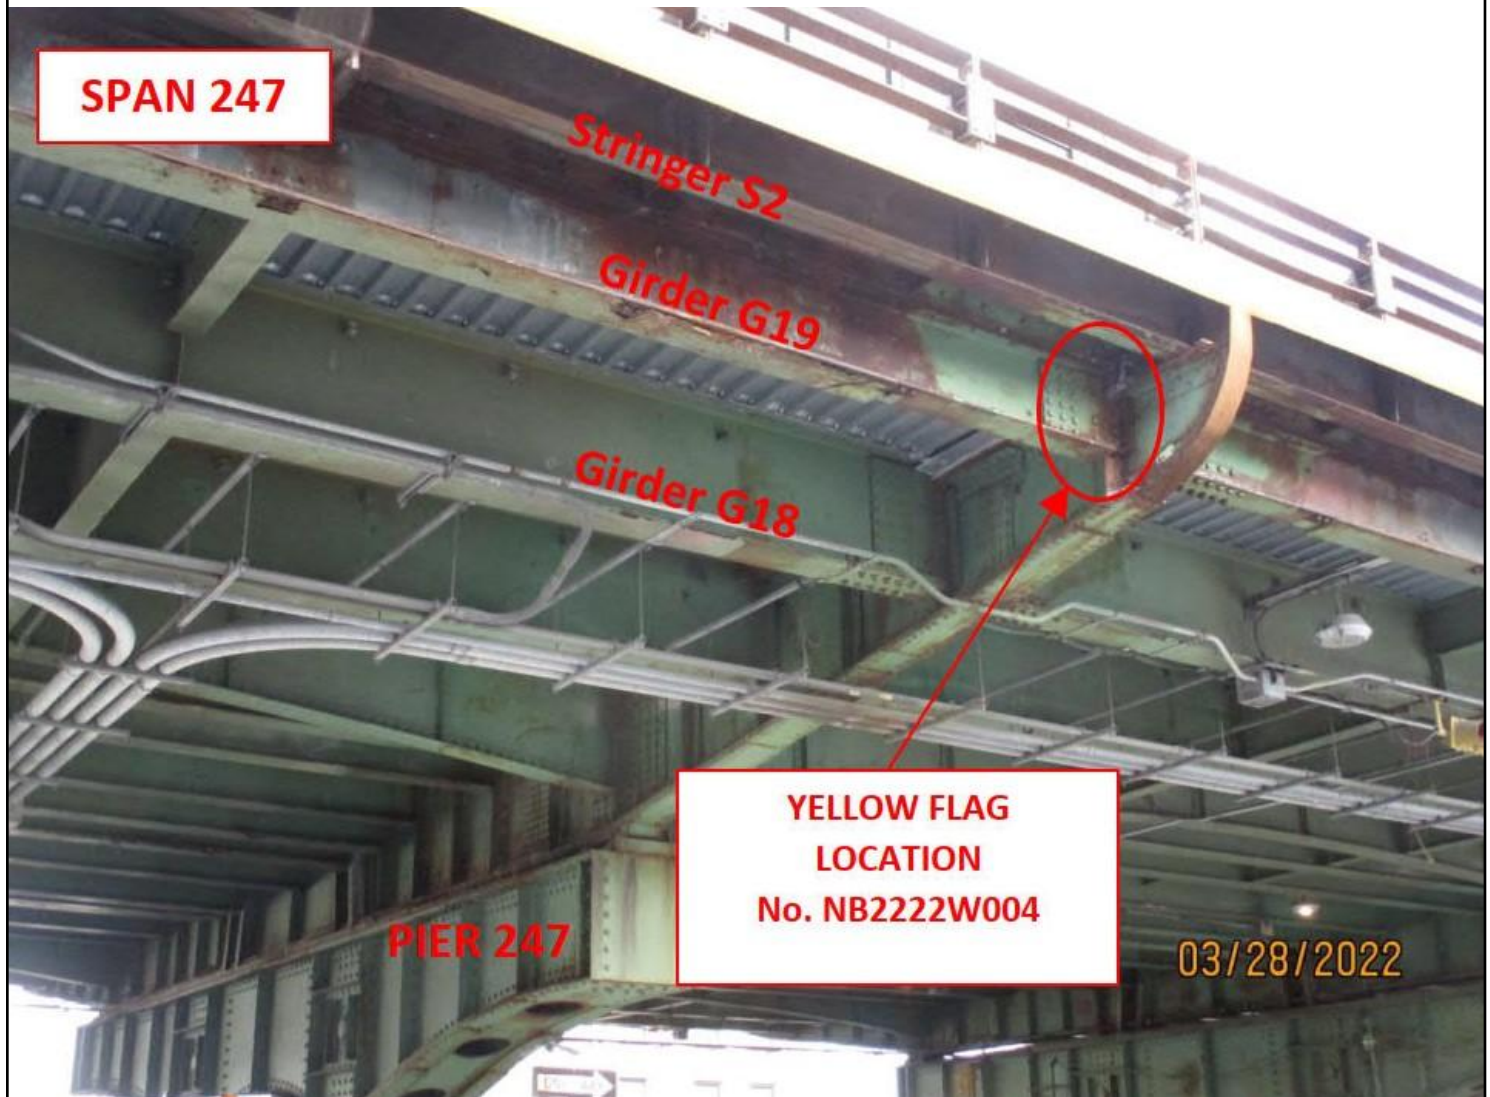
Photo Number: 1

**Attachment Description:** Span 247, Girder G19 at Pier 247. General view of flagged location at the pier cap connection. Looking end left.

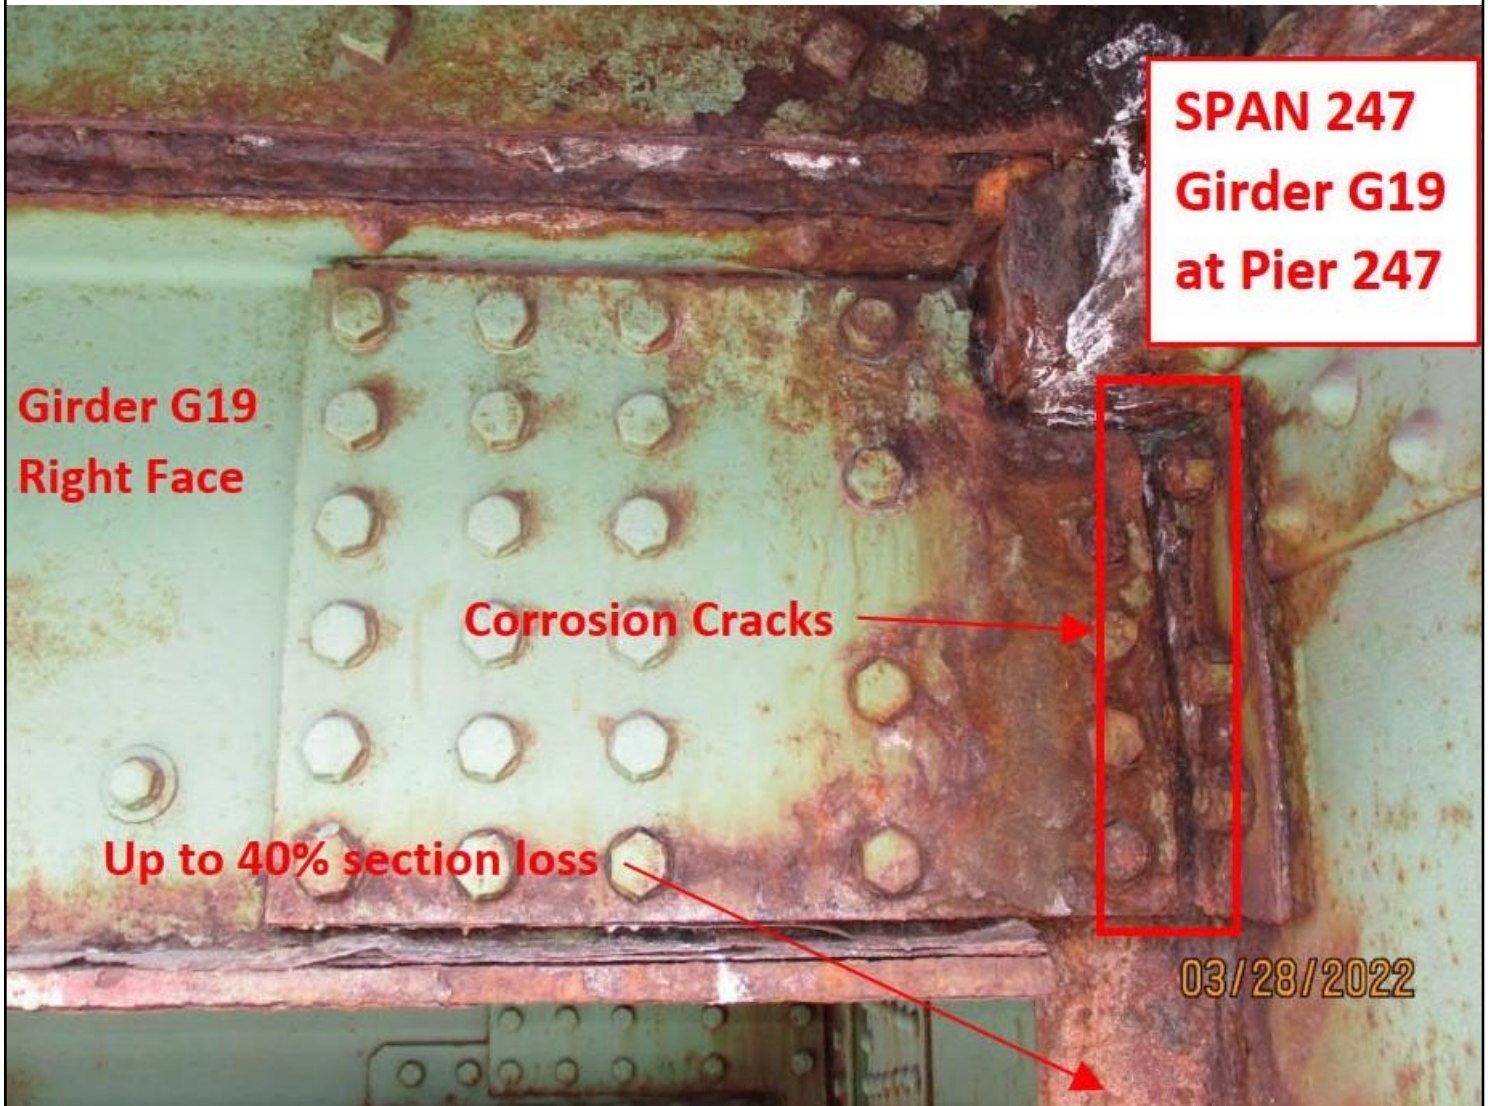
Photo Number: 2

Description: The right connection angle at Girder G19 to the pier cap at Pier 247 exhibits a 5" H x 3/4" W vertical corrosion crack at the lower fillet section (no change from the previous inspection) and an 8.25" H x 3/4" W vertical corrosion crack at the upper fillet section (no change) (Photos 2 and 3). The remaining 1.25" of the connection angle height exhibits up to 90% section loss.

**Attachment Description:** Span 247, Girder G19 at Pier 247. Close-up view of flagged location. Looking left.

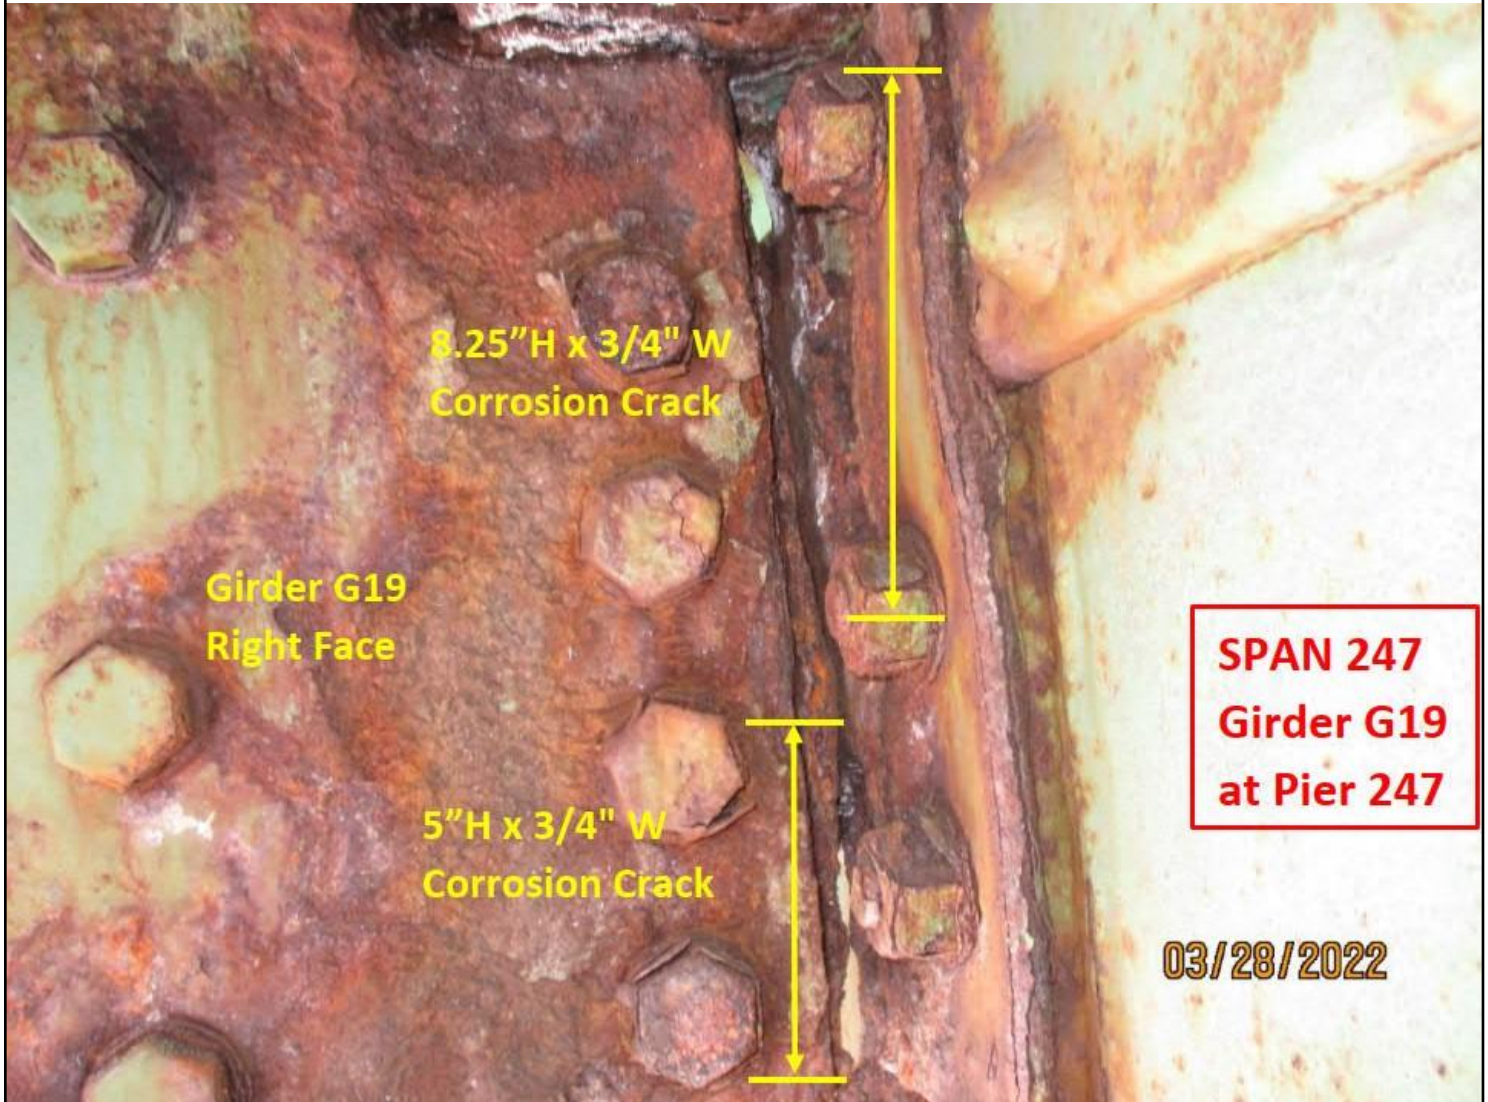
Photo Number: 3

**Attachment Description:** Span 247, Girder G19 at Pier 247. Close-up view of Corrosion Cracks and heavy section loss of the right connection angle. Looking left.

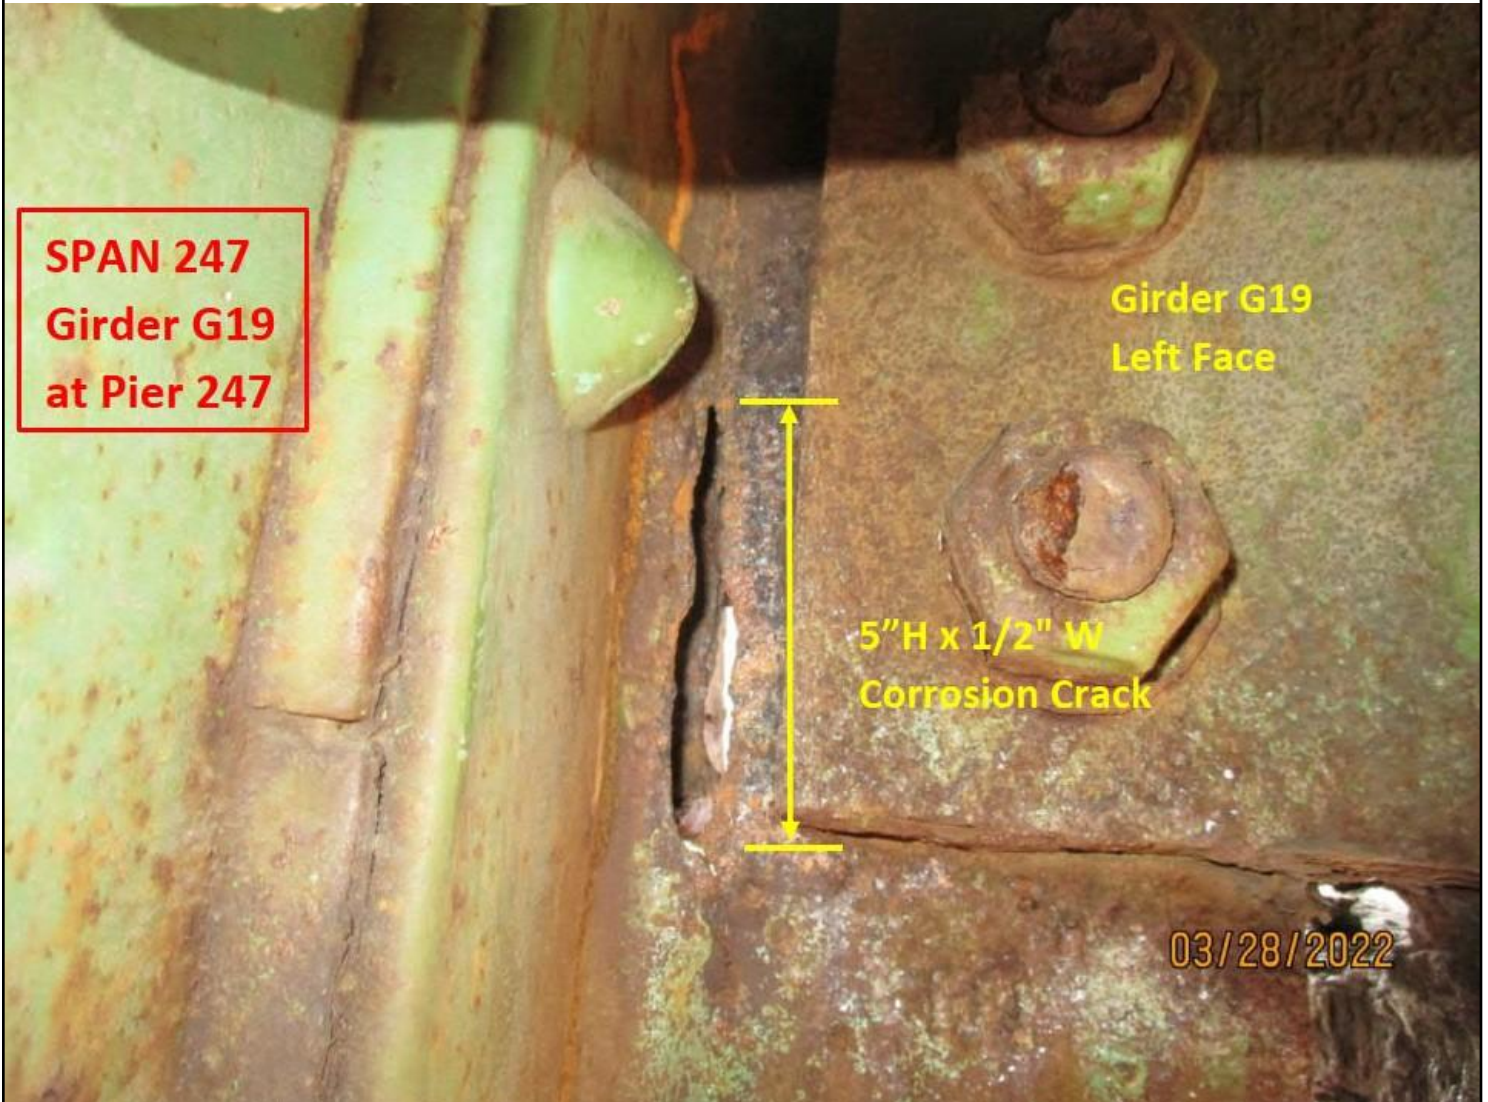
Photo Number: 4

The left connection angle exhibits a corrosion crack at the top measuring 2" L x 1/2" W that extends to a 2.5" long crack directly below (previously noted to be 2.25" long) (Photos 4 and 5). Additionally, there is a 5" H x 1/2" W corrosion crack at lower portion of fillet. The remaining area of the connection angle exhibits up to 40% section loss.

**Attachment Description:** Span 247, Girder G19 at Pier 247. Close-up view of corrosion crack and heavy section loss of the left connection angle, lower section. Looking Right.

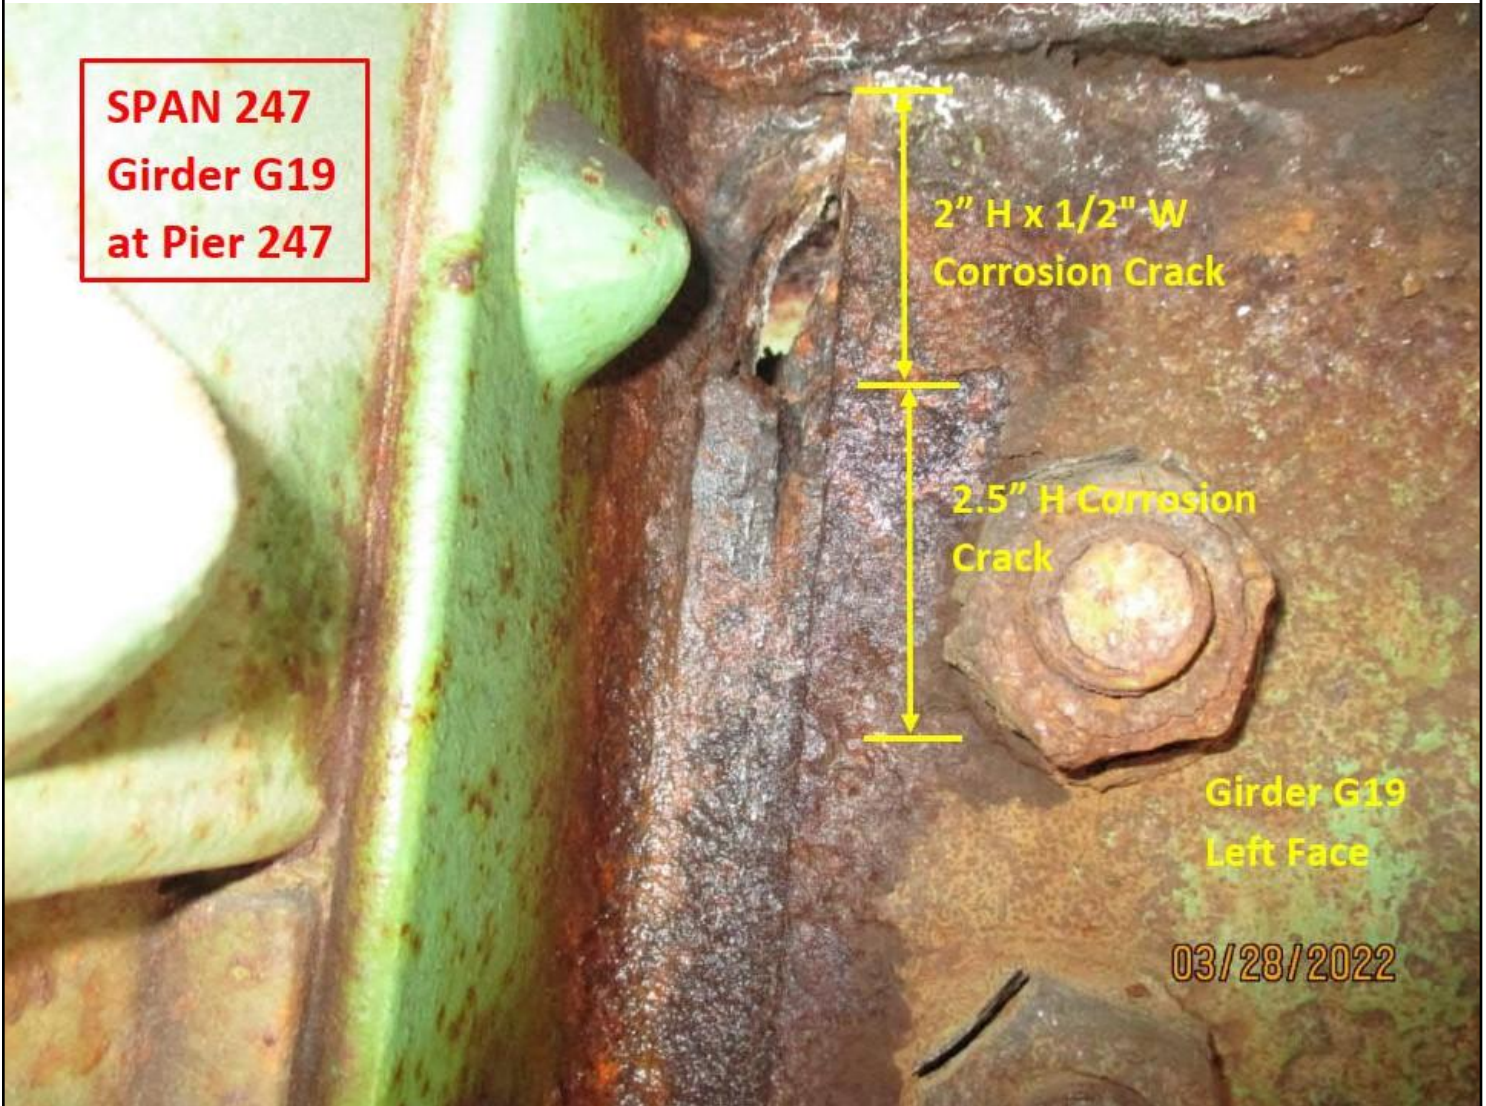
Photo Number: 5

**Attachment Description:** Span 247, Girder G19 at Pier 247. Close-up view of corrosion crack and heavy section loss of the left connection angle, upper section. Looking Right.

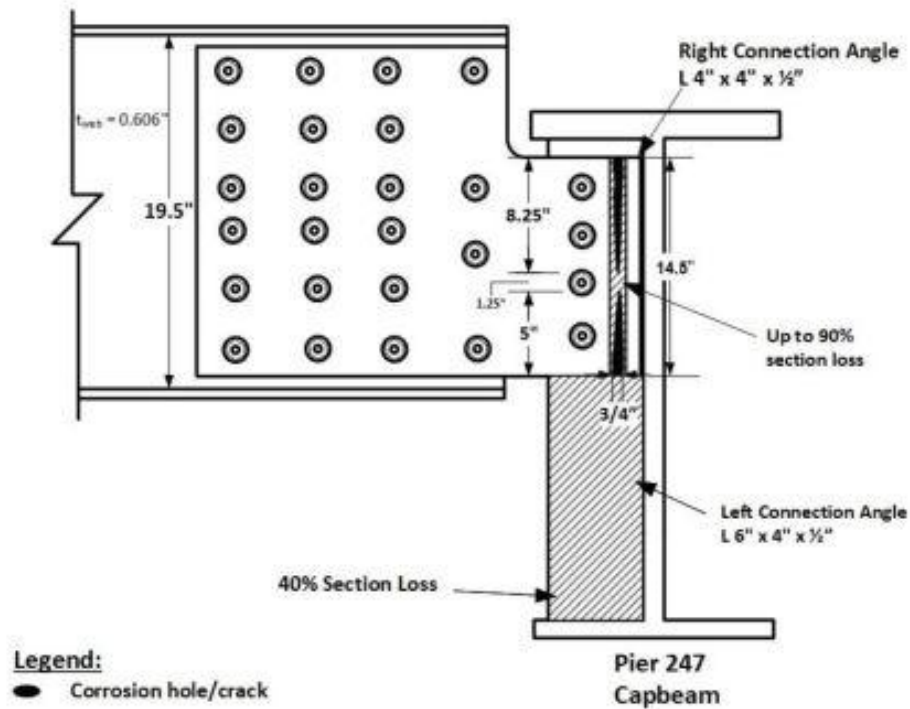
Photo Number: 6

***Attachment Description: Span 247 G19 at Pier 247 Sketch Looking Left***

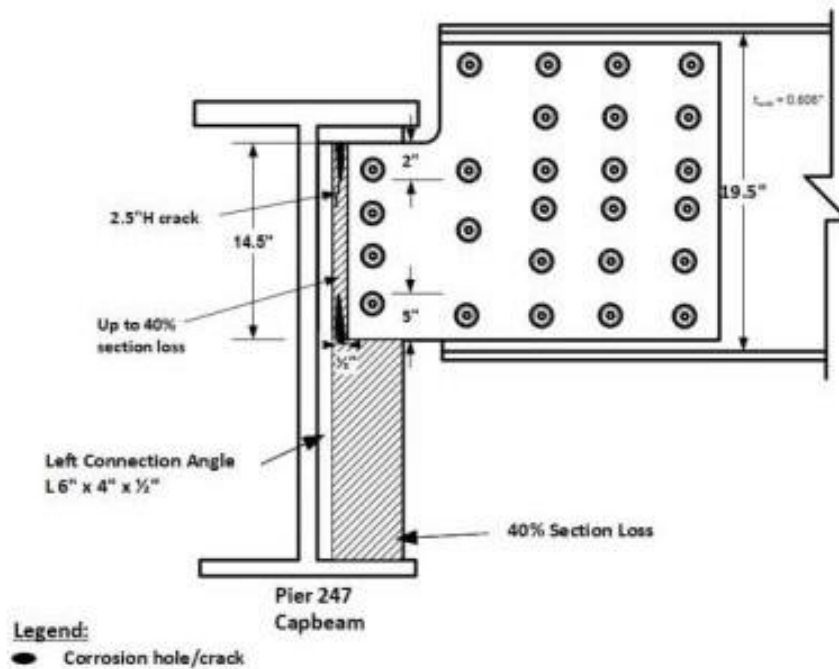
Photo Number: 7

Span 247, Girder G19 at Pier 247  
(Looking Right)  
N.T.S

***Attachment Description: Span 247 G19 at Pier 247 Sketch Looking Right***

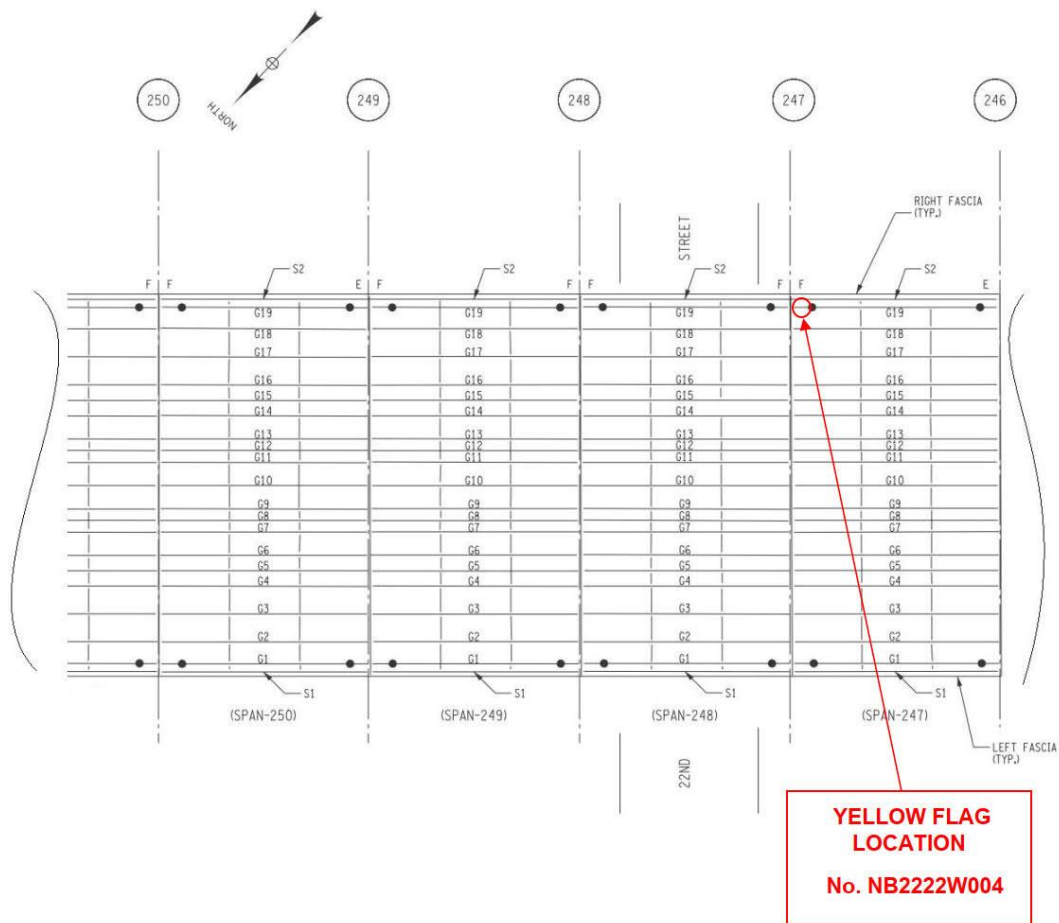
Photo Number: 8

**Attachment Description: Span 247 G19 at Pier 247 Framing Plan**
